## INTEGRATED VEHICLE HEALTH MANAGEMENT

### ***Lightning Damage Diagnosis Research for Composite Aircraft***

***George Szatkowski***

Aviation Safety Program Technical Conference  
November 17-19, 2009  
Washington D.C.

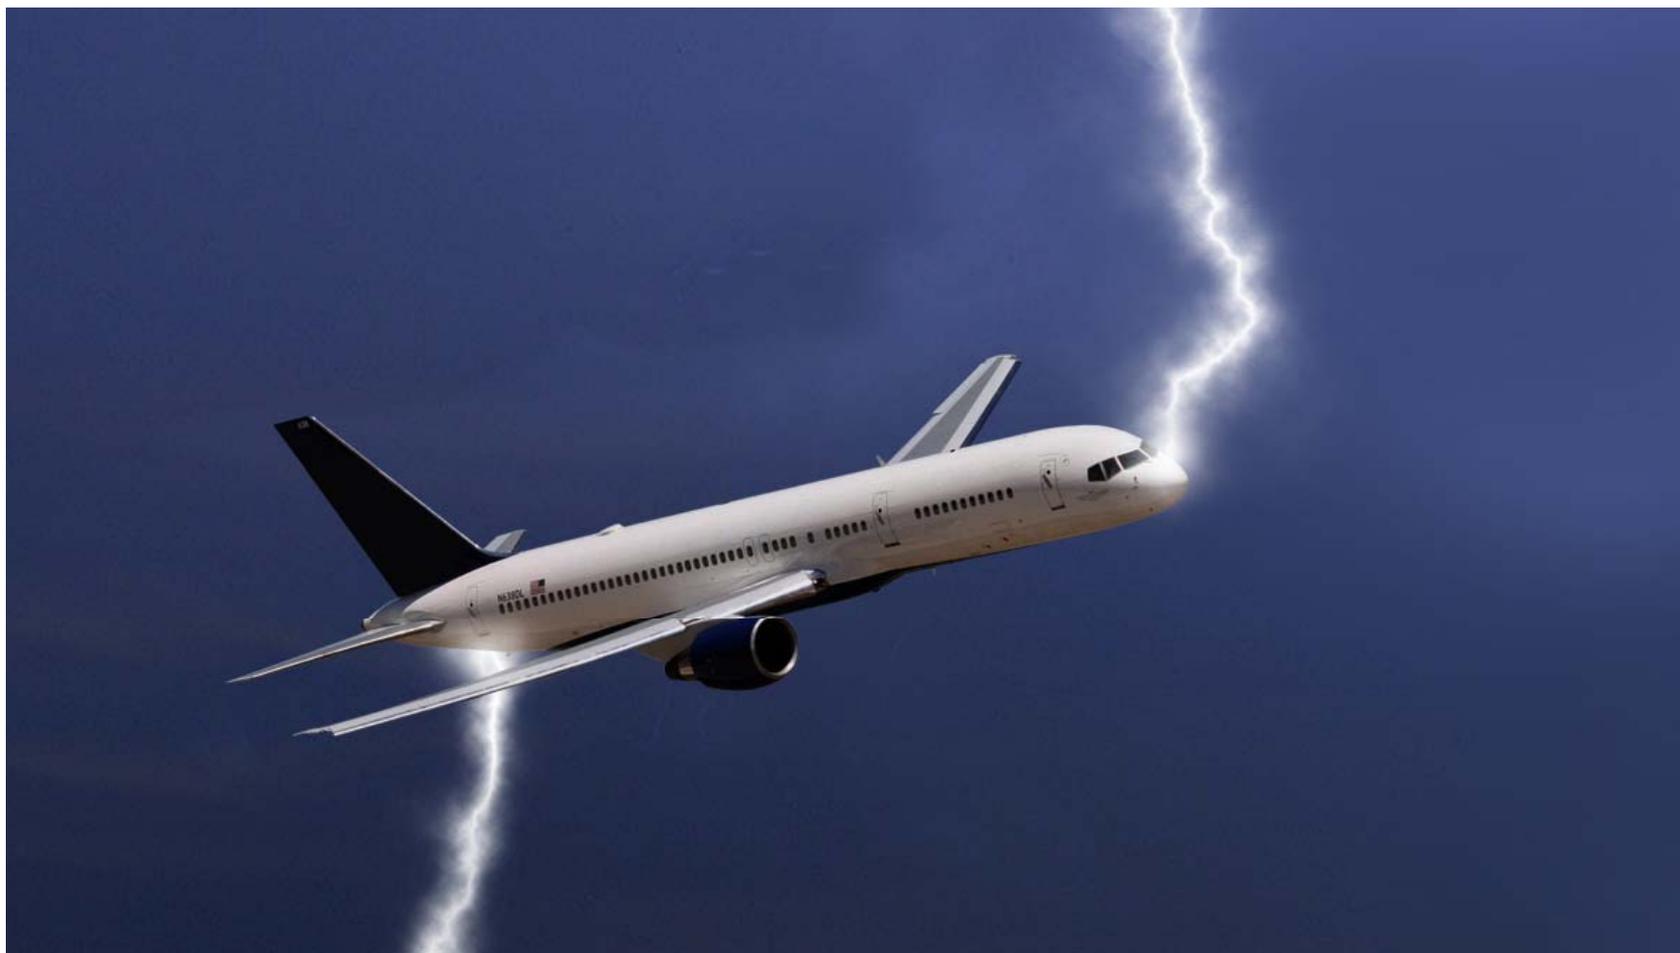
- When lightning strikes a composite aircraft
  - Structural IR voltages are much greater
  - Magnetic flux penetrates deeper into the fuselage skin
  - New emphasis needed for lightning strike protection (LSP)
    - Structural failure
    - Fuel tank explosion
    - Avionic upset or damage
  - Pilot are often times unaware if an aircraft was struck
  - Visual inspections are performed to look for damage
  - Lightning damage on composites is viewed the same as other mechanical damage

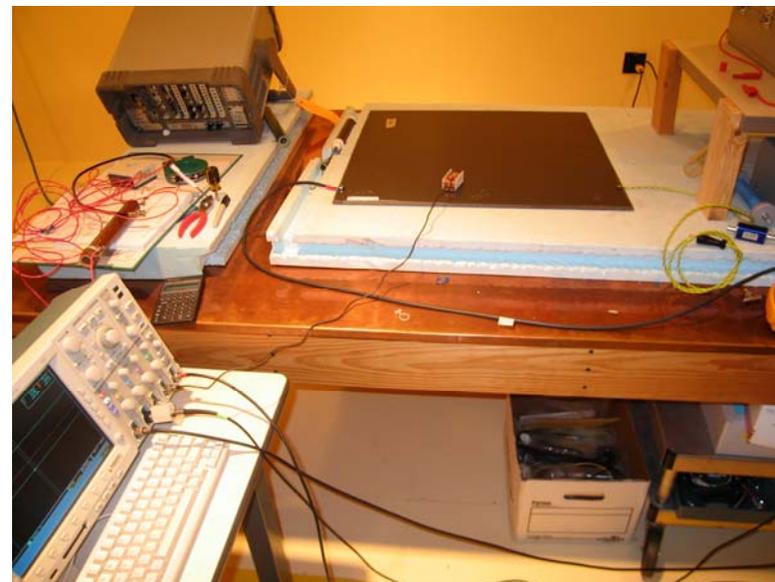
### Surface Current Mapping

- Induce indirect effect electrical currents using simulated lightning waveforms in on the panel edges.
- Correlate Time & Frequency domain techniques.
- Evaluate lighting detection sensors.
- Captured waveforms will provide insight into electrical properties which influence lightning current propagation.
- Various techniques will be explored to determine the best method to expose the carbon fibers for current injection.
- Provide measurement results to modeling community.

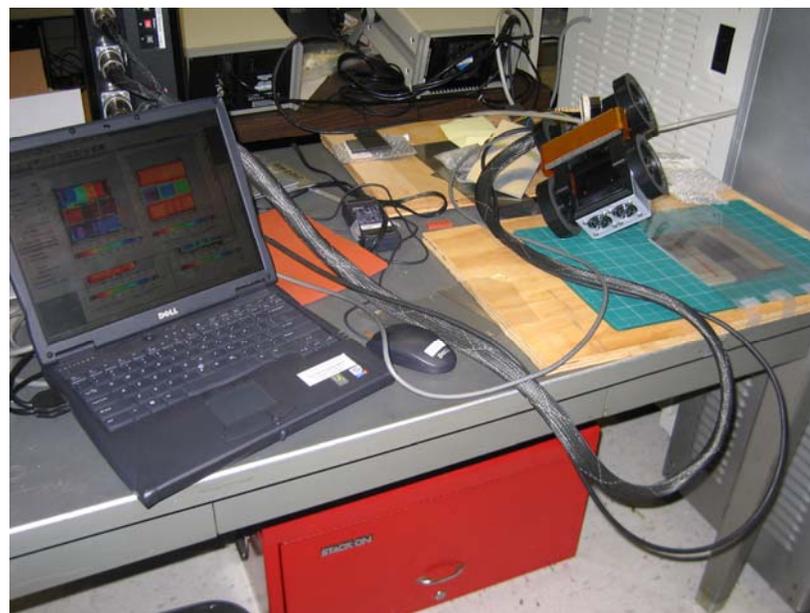
### Eddy Current Measurements

- Monitor voltage as a function of position from an electromagnetic coil moved along the surface of a composite panel to calculate surface impedance parameters.
- Identify irregularities in the lightning protection conductor or composite structure beneath.
- Research sponsored by Aircraft Aging and Durability (AAD) Project
- Test results will be correlated with other nondestructive evaluation (NDE) techniques for anomaly detection.

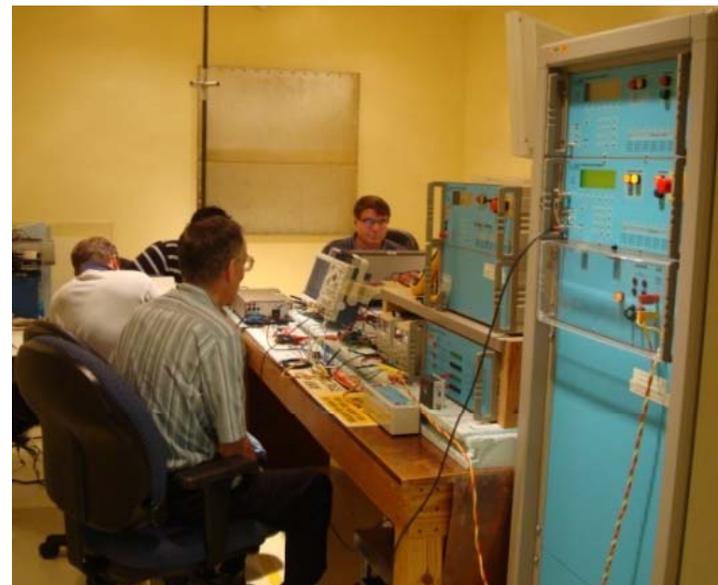
### Lightning Pin Injection Testing on Power-MOSFETs

- Research lead by NASA Ames
- LaRC HIRF Facility personnel developed test procedures to expose MOSFETs to lightning test waveforms 3, 4 & 5
- MOSFETs tested in OFF State, Jan 2009
- MOSFETs tested in On State, May 2009
- Lightning equipment upgraded in 2009
- “Lightning Pin Injection Testing on MOSFETs”, NASA/TM-2009-215794 “, Sept. 2009
- “Effects of Lightning Injection on Power-MOSFETs”, PHM Society Conference, Oct. 2009.

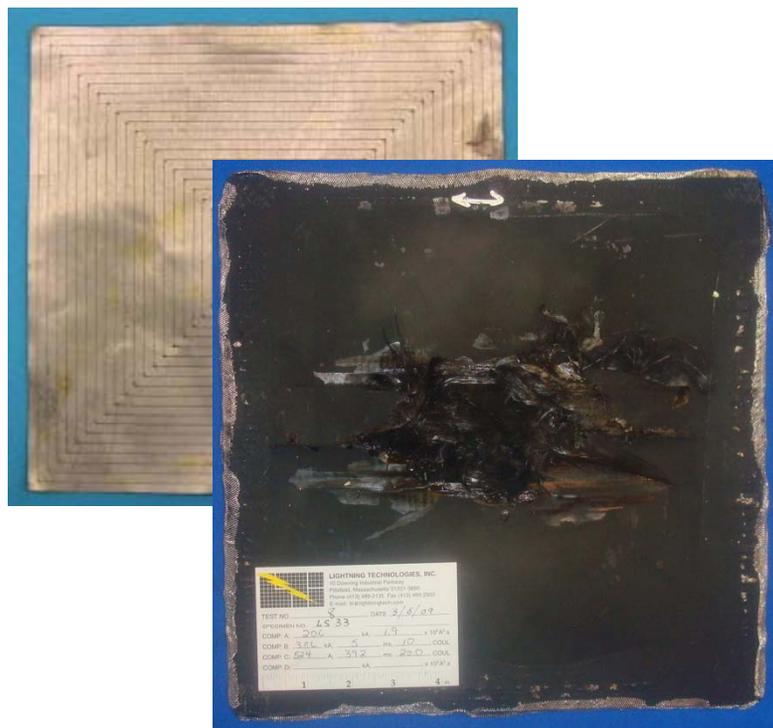
- Investigate applicability of Open Circuit Resonant Sensors
- Multifunctional use: composite damage, stress, strain, air pressure, temperature
- Measure impedance of surrounding material
- Challenges: poor performance on conductive surfaces

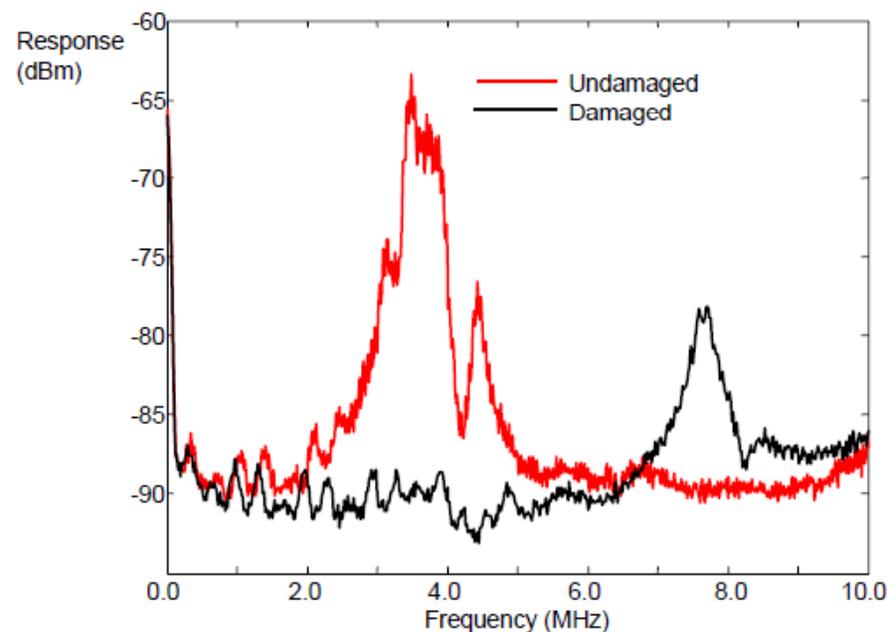
Typical Expected Theoretical Response
